ENFORCEMENT CONFIDENTIAL – Not Releasable Under Freedom of Information Act
Spill Prevention Control and Countermeasures Inspection
COMPLIANCE INSPECTION REPORT

COS SAMOA PACKING COMPANY
TUNA CANNERY

Inspection Date: January 28, 2008

SPCC Case No.: 08-xxxx

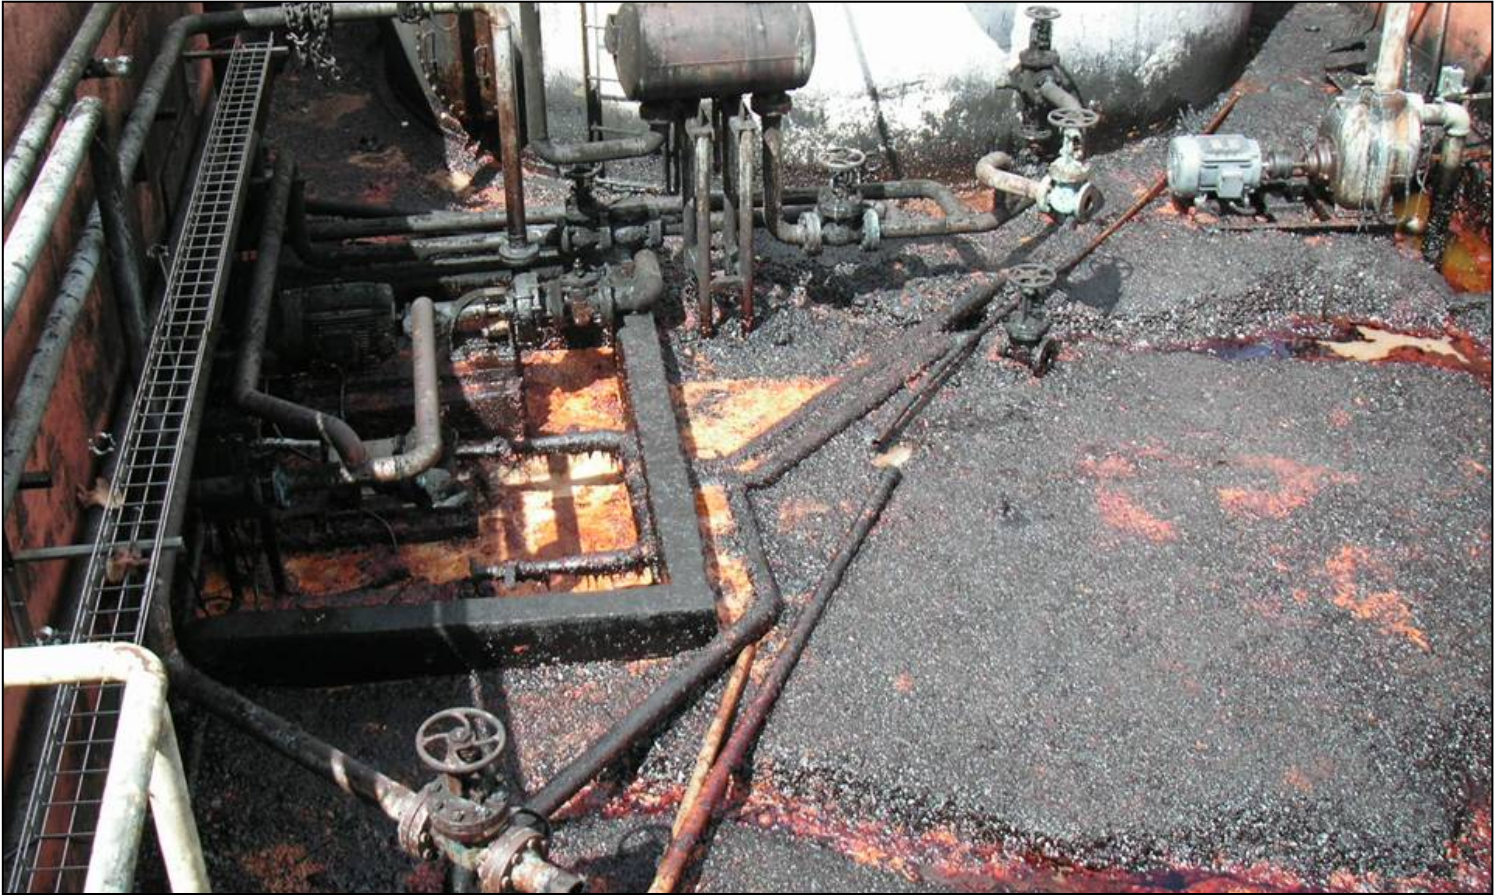
Photo No. 1: Significant amount of soybean oil outside secondary containment.

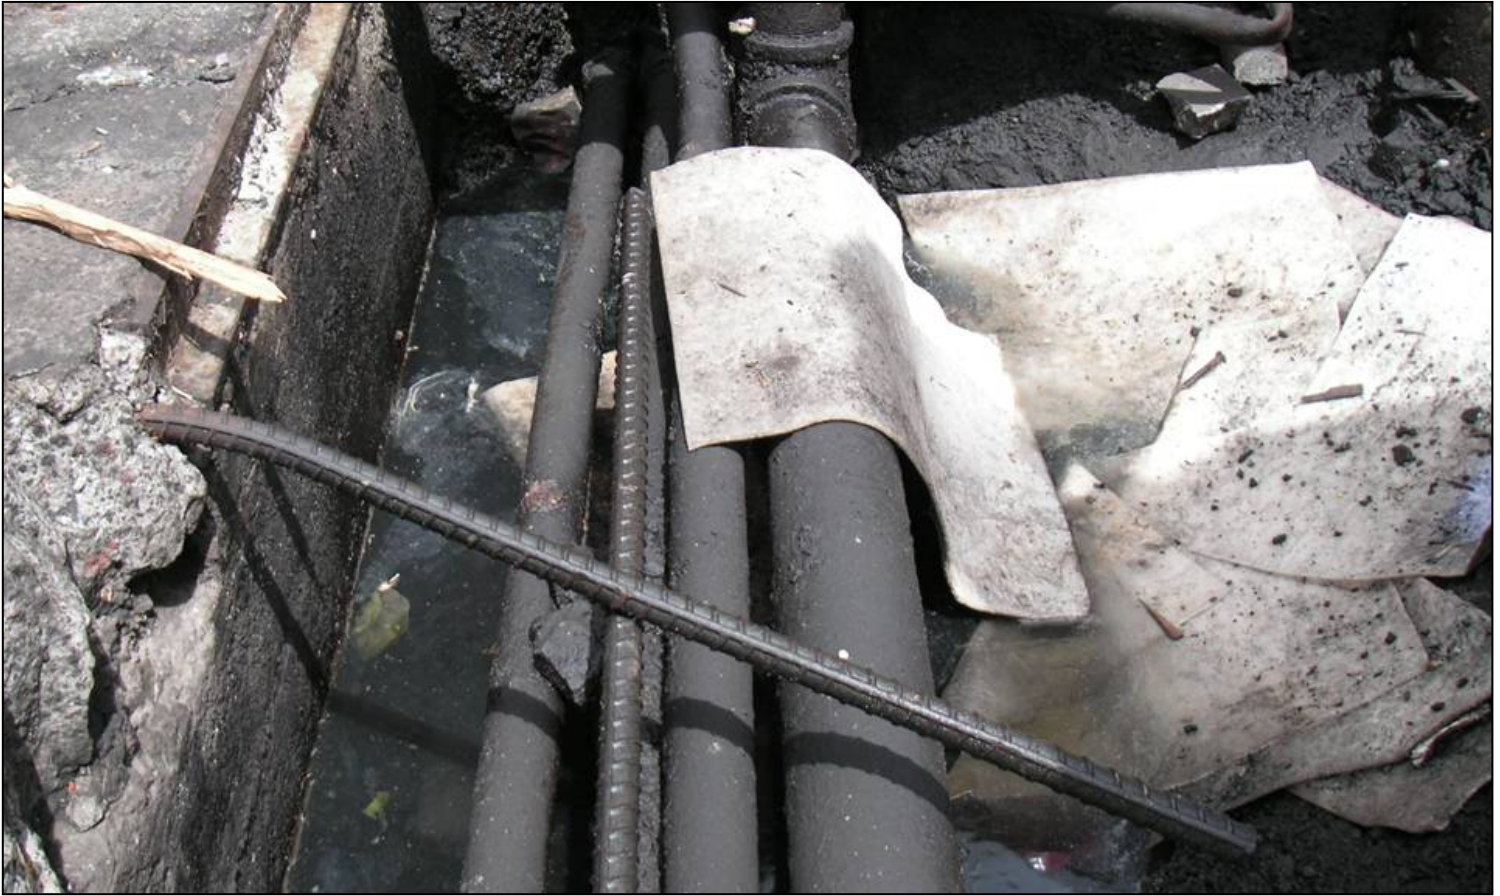
Photo No. 2: Oil residue observed in piping trench. Note that the metal piping is not protected from corrosion.

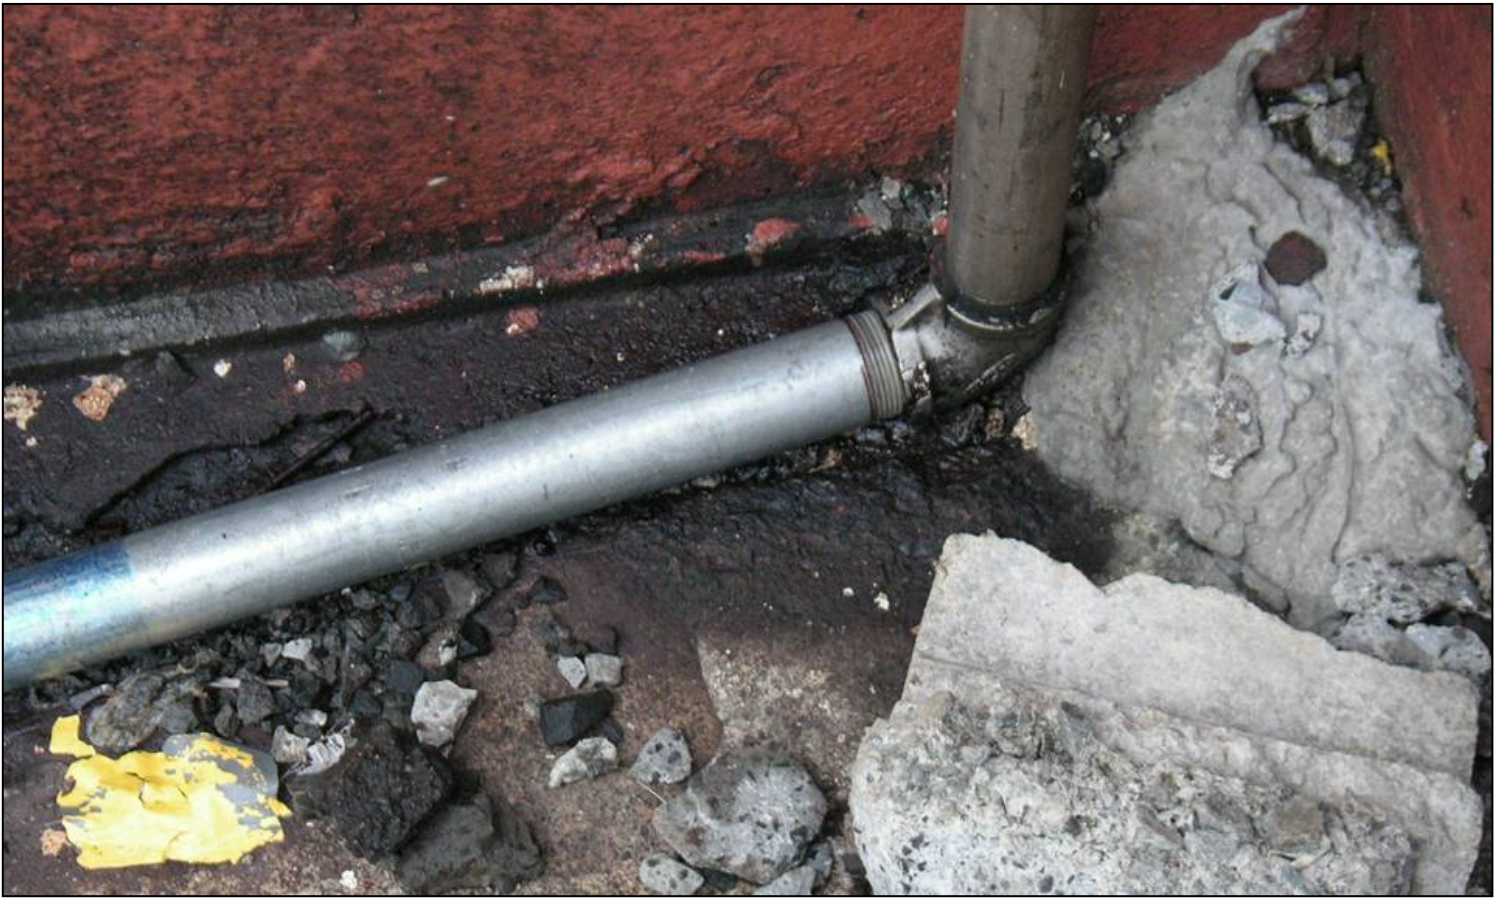
Photo No. 3: A leaking section of piping that was recently replaced.

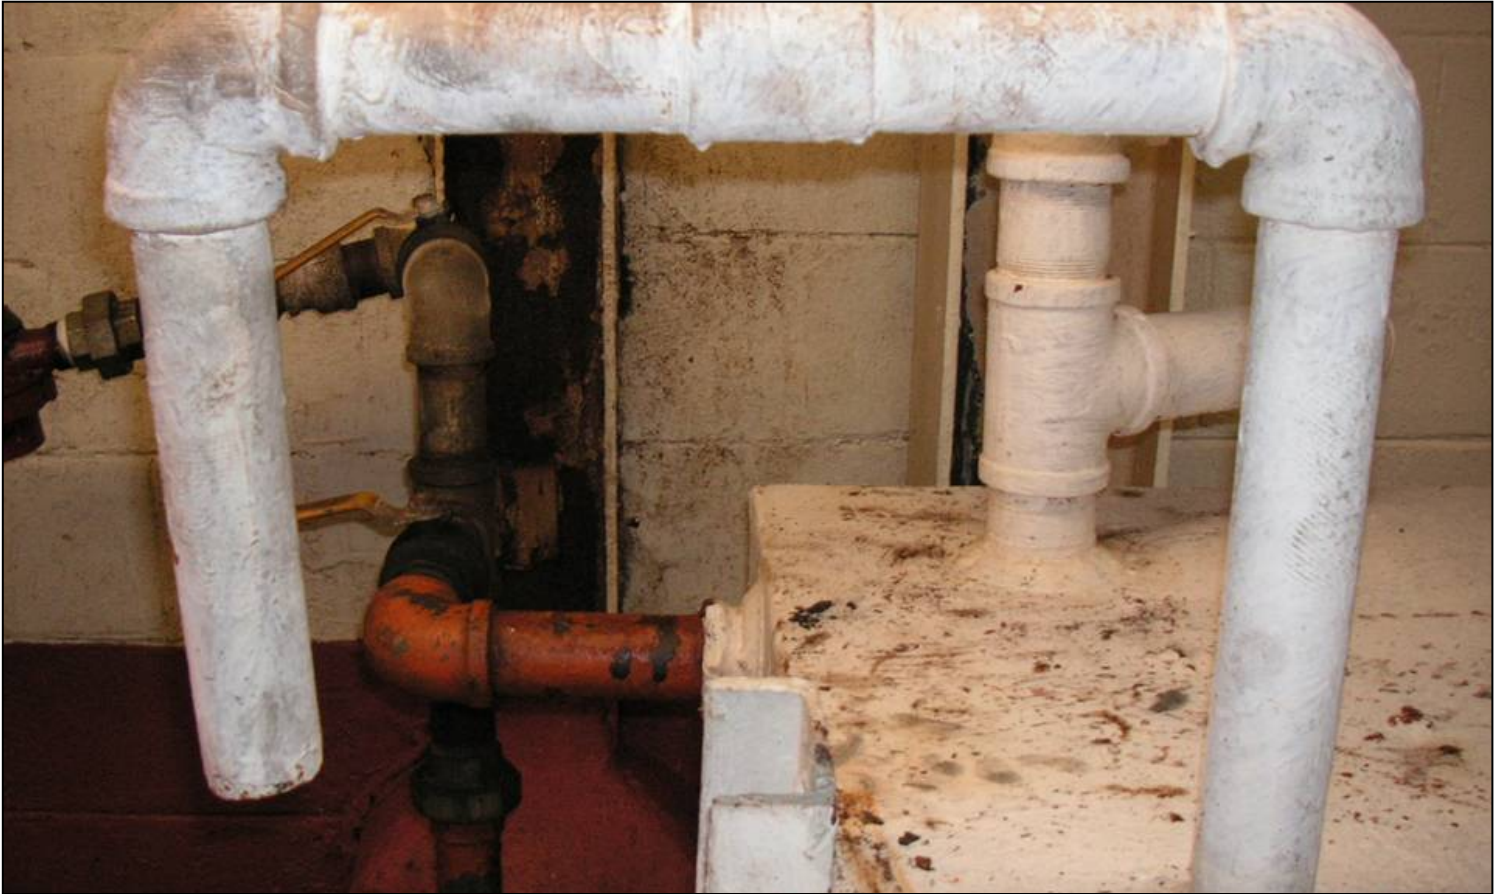
AOC: 2	The diesel generator day tank is venting into the plant rather than outside the plant into open air. If the bypass valve is open like it was at the time of the spill, there is no spill or overfill protection, there is no return line to the bulk diesel tanks, and no high liquid level alarm or cutoff devices. Please submit evidence that this issue has been addressed (Photos No. 5 & 6).

Photo No. 5: Diesel day tank venting in the plant rather than outside. The 4200 gallon overfill originated from this vent pipe.

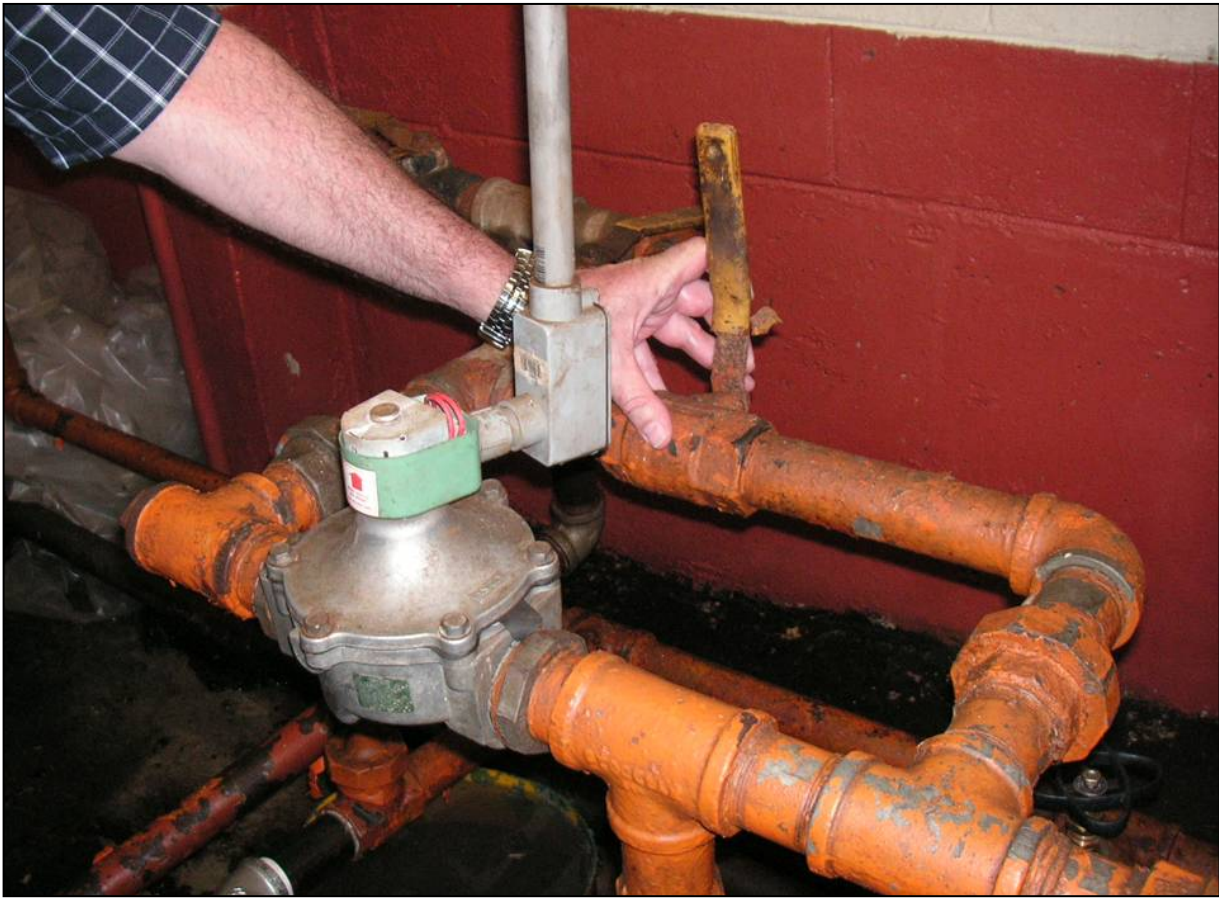
Photo No. 6: The bypass valve was left open at the time of the overfill.
